Tisseos[®]
Resorbable synthetic membrane

Case studies

Clinical case study
Dr. HOORNAERT Alain
Nantes, France

Socket preservation and bone ridge augmentation

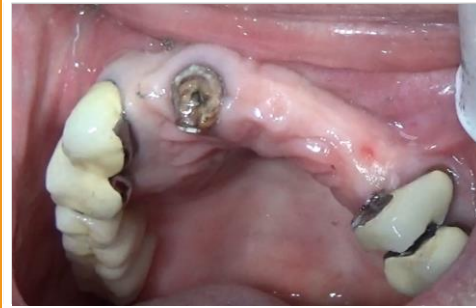
Initial clinical situation

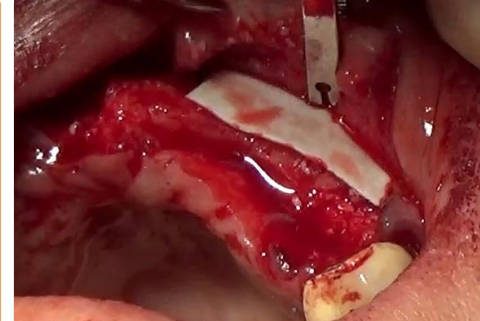
Positioning of Tisseos® membrane

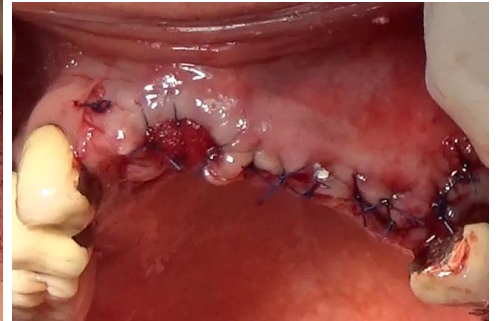
Postoperative view

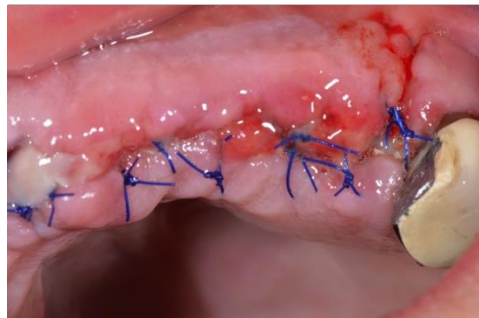
Gingiva healing at 8 days

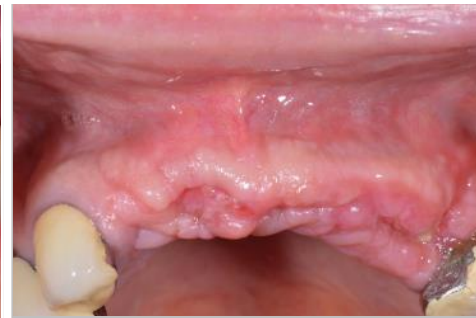
Clinical situation after 4 months showing vertical and horizontal bone augmentation

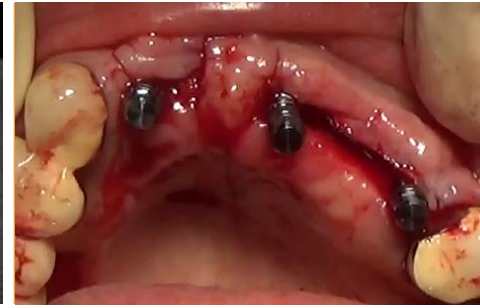
Insertion of 3 implants

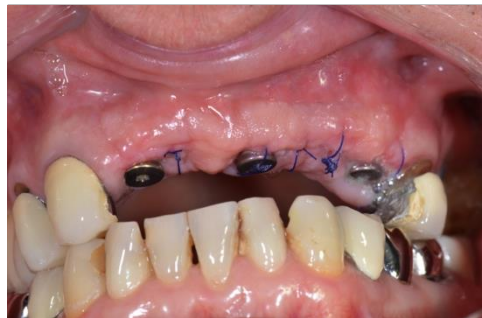
Placement of covering screws

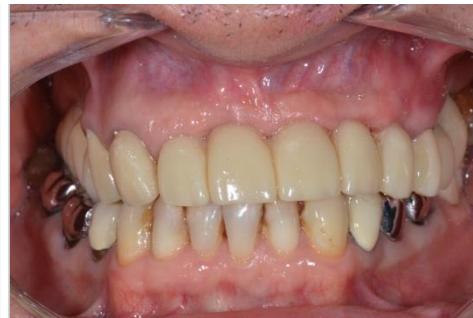
Temporary prosthetics
restoration
