Tisseos[®]
Resorbable synthetic membrane

Case studies

Clinical case study
Dr. EVANNO Charles,
Liré, France

Dehiscence coverage

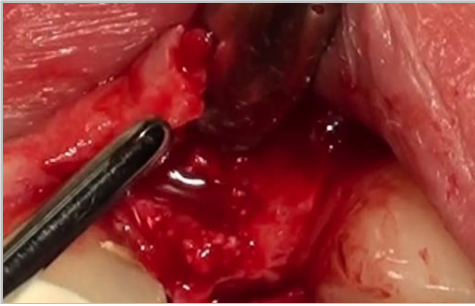
Initial clinical situation

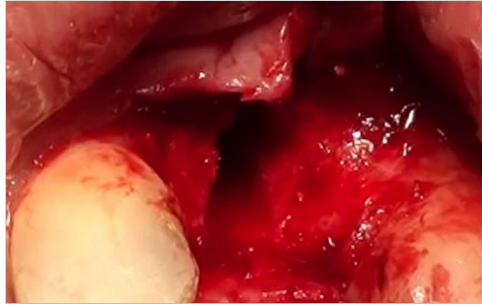
Alveolar ridge after opening of the gingiva

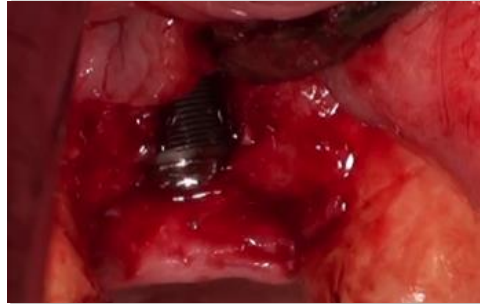
Implant with exposed turns

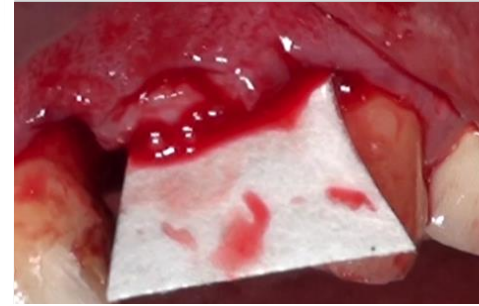
Placement of Tisseos® membrane

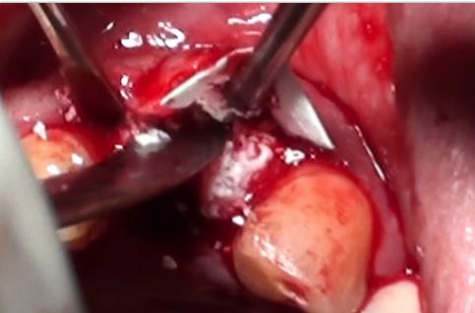
Filling with the biomaterial

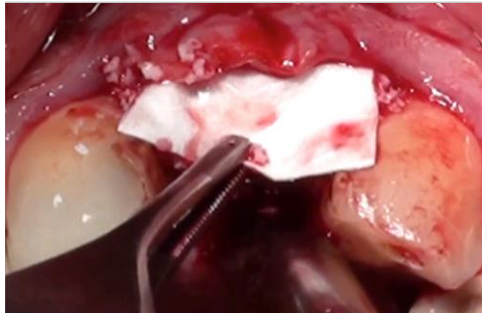
Repositioning of the membrane

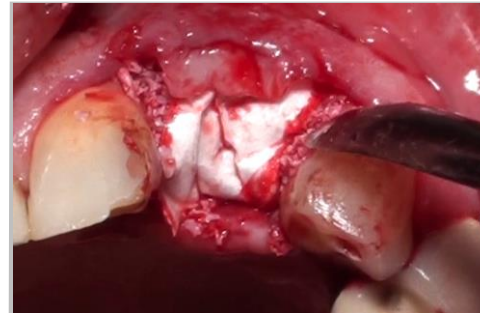
Palatal insertion

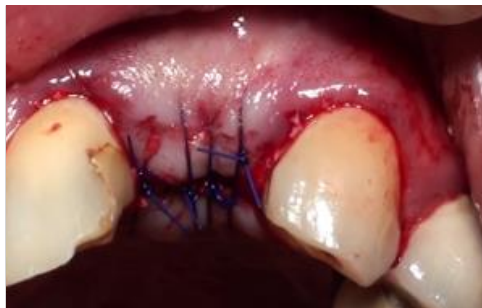
Sutures

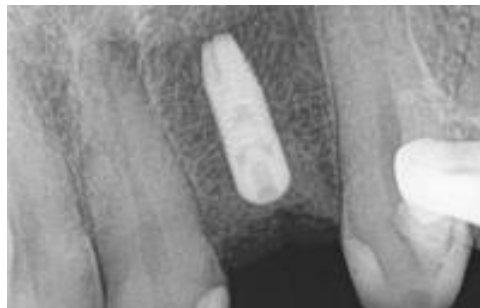
X-ray

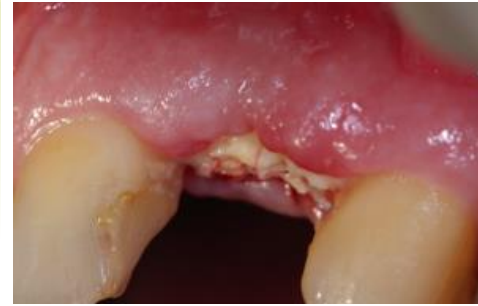
Membrane exposure at day 8

- When filling a large defect, it may be difficult to close the gingival tissue without tension. The membrane may then become exposed during the gingival healing.
- If exposed, Tisseos® membrane maintains its physical integrity, prevents leakage of the biomaterial and prevents infection of the site.
- The healing of the gingiva is favoured by the guided tissue regeneration properties of the Tisseos® membrane.
- After exposure, the gingival tissue will heal and close in 2 weeks without losing the barrier effect.
- Mouth wash with antiseptic solution and local application of a Chlorhexidine gel are recommended in case of membrane exposure.

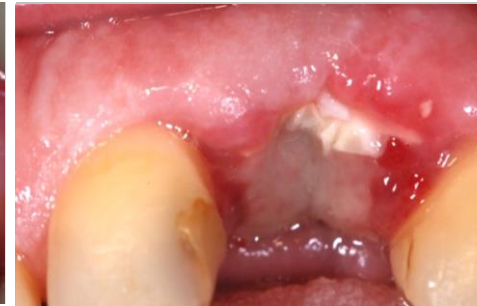
Gingival healing at day 16

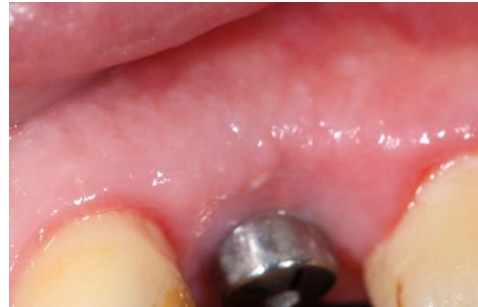
Placement of the cover screw
at 1 month
